Manhole Inspection Summary

Manhole # S49E__017MH

Insp Date: **3/9/09 1:47 PM**

Location Address: **2600 E BALTIMORE-FAIRMONT-ALLEY** Cross Street: **N LUZERNE AV**

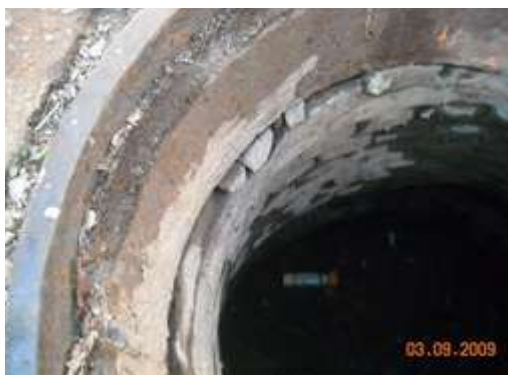
Defect 3

Frame Offset: **1** (in.) Condition: ☒ Sound ☐ Cracked ☐ Leaks

Corbel Material: **Brick** ☐ Parged Type: **Concentric/Eccentric**
Condition: ☐ Sound ☐ Cracked ☐ Root Intrusion ☒ Loose Brick ☒ Deteriorated
Infiltration: ☐ None ☒ Joint ☐ Cracks ☐ Mortar ☐ Roots ☐ Wall

FRAME OFFSET; LOOSE BRICKS,
DETERIORATION AND INFILTRATION
IN CORBEL

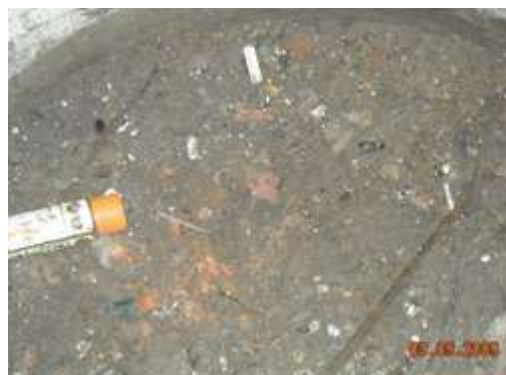
Defect 2

DEBRIS ON STEPS

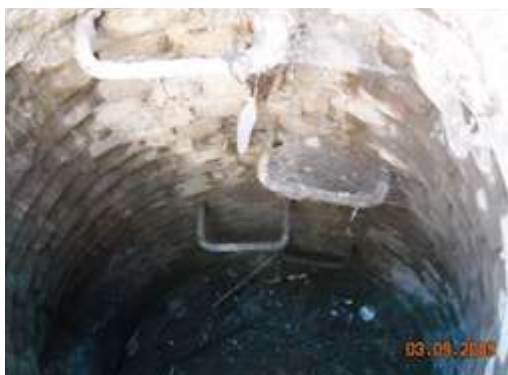
Defect 1

Steps Count: **4** Missing: **0** ☒ Corroded

CORRODED STEPS
